Pool & Spa Corner

Repair Procedure for Exposed or Shallow Reinforcement

by Ron Lacher

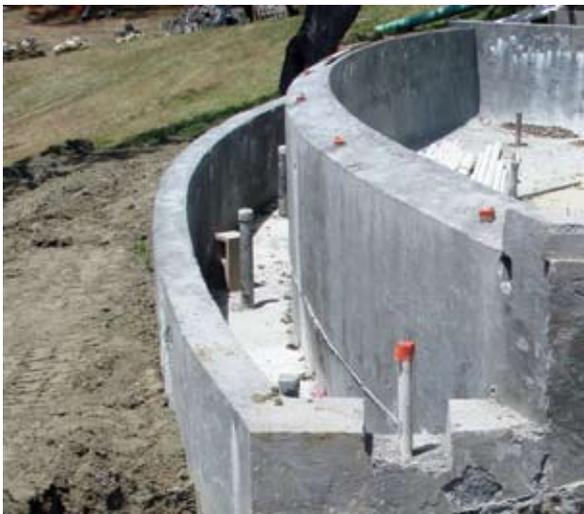
On vanishing edge pools, the weir wall and often the outer basin wall must be formed for shotcrete application. Forms are usually erected on the outside of the wall

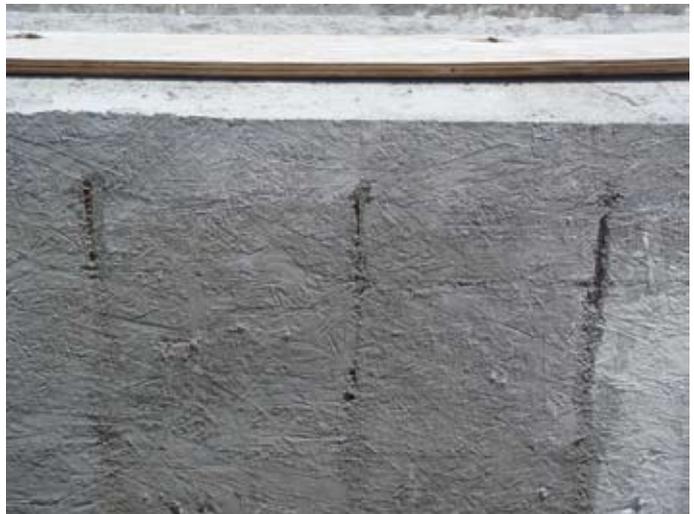
The dobies slipped out during shotcrete application, allowing the reinforcement and formwork to come together, leaving essentially no cover over the reinforcement

the forms. This resulted in the reinforcing bars and formwork coming together, leaving essentially no cover to the reinforcement. The problem became very apparent when the forms were removed. To make matters worse, when the forms were stripped, portions of the outer surface of the shotcrete basin wall delaminated from the wall. Both of these occurrences resulted in inadequate shotcrete coverage over the steel reinforcement. Unless corrected, the weir wall would be subject to ongoing problems that eventually could result in failure of the wall. We can learn several valuable lessons from this pool builder's misfortune.

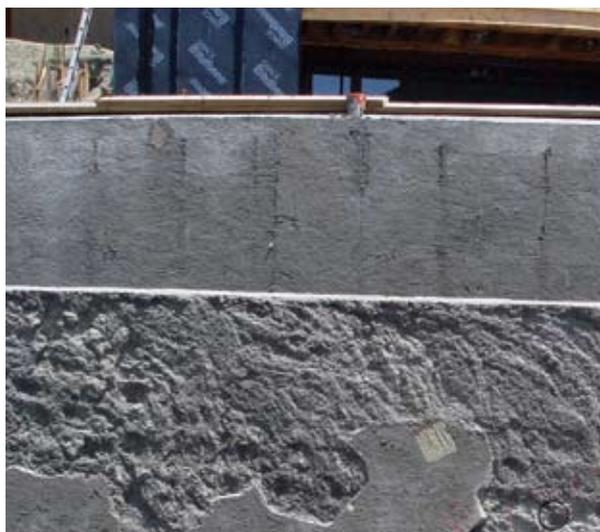
When the forms were stripped, the outer surface of the basin wall delaminated, leaving substandard coverage over the reinforcement. Note the exposed reinforcement in the weir wall in the background

that both the inner and outer surfaces of these walls be waterproofed against moisture penetration. We do not consider the typical pool plaster or pebble surface coating to be waterproofing. If this waterproofing recommendation is followed, the reinforcement would no longer be considered exposed to weather and a minimum of 0.75 in. (20 mm) of shotcrete cover would be required by building codes. Where this required cover is not provided, as in the case of exposed reinforcing steel or delamination of the shotcrete surface, additional shotcrete cover must be added to provide the required cover.
